Report of Dam Safety Assessment of Coal
Combustion Surface Impoundments
American Electric Power (AEP) and Southwest
Electric Power Company (SWEPCO)
H.W. Pirkey Power Plant, Hallsville, TX

AMEC Project No. 3-2106-0183.0003

June 2011

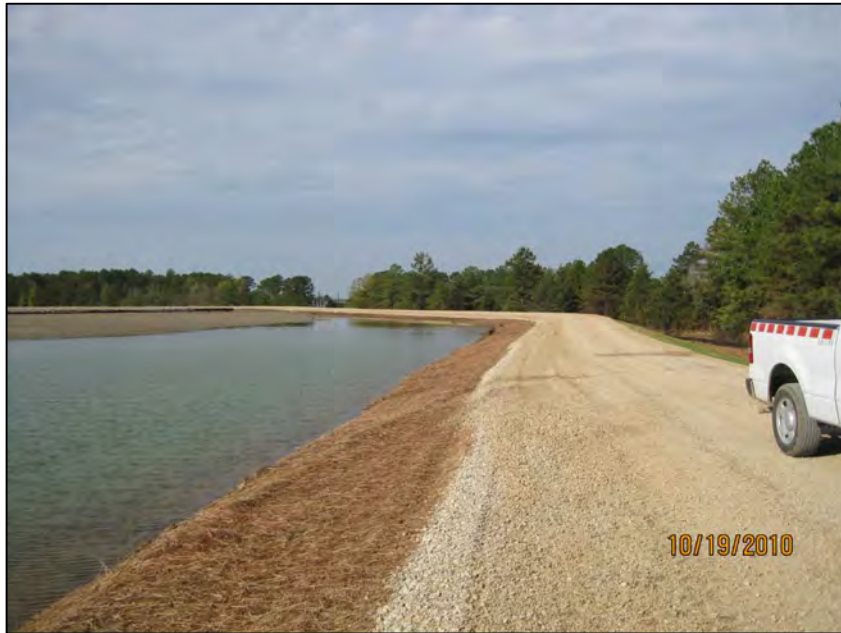
WAP-13
LOOKING WEST FROM CREST OF NORTHERN EMBANKMENT

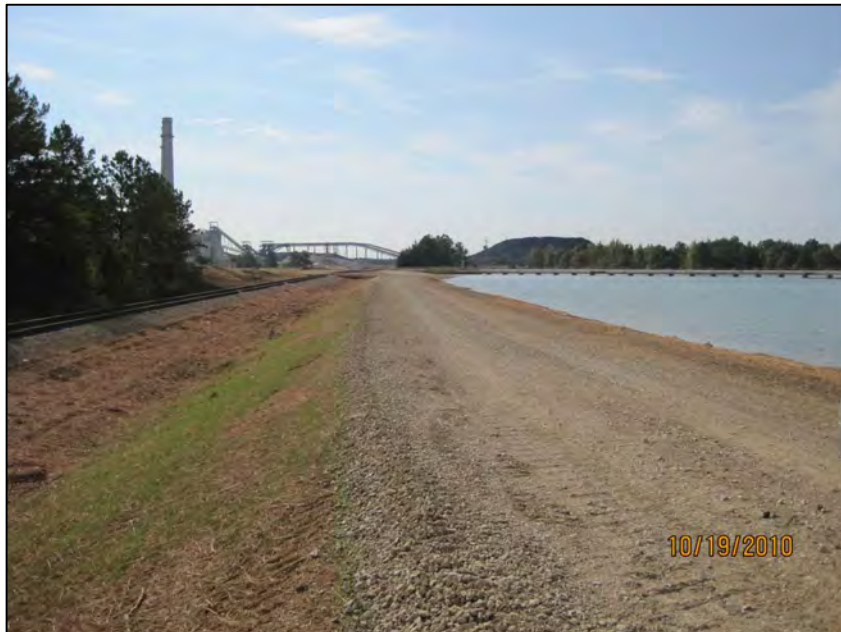
WAP-14
LOOKING SOUTH FROM CREST OF EASTERN EMBANKMENT

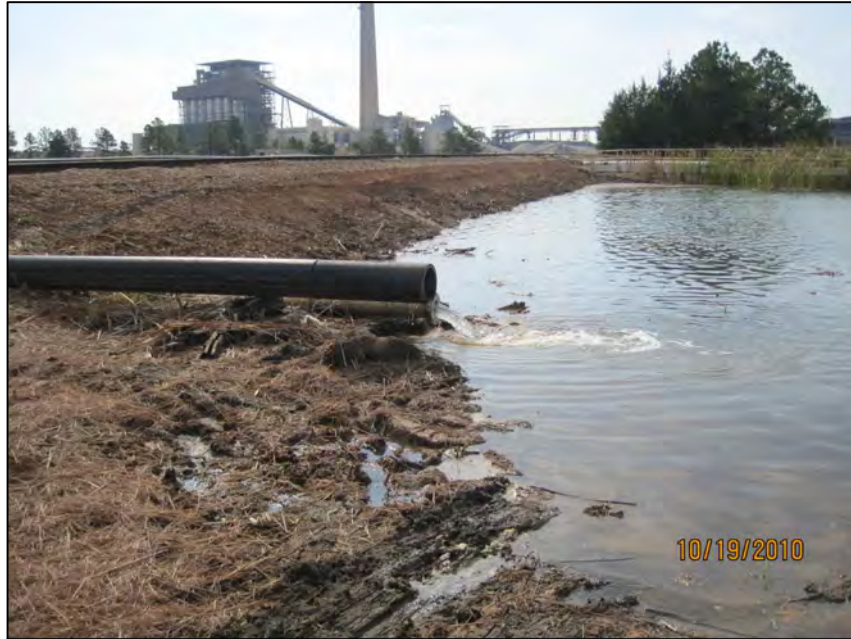
WAP-15
LOOKING SOUTH AT INFLUENT PIPE-NEUTRALIZED
WASTE FROM DEMINERALIZER

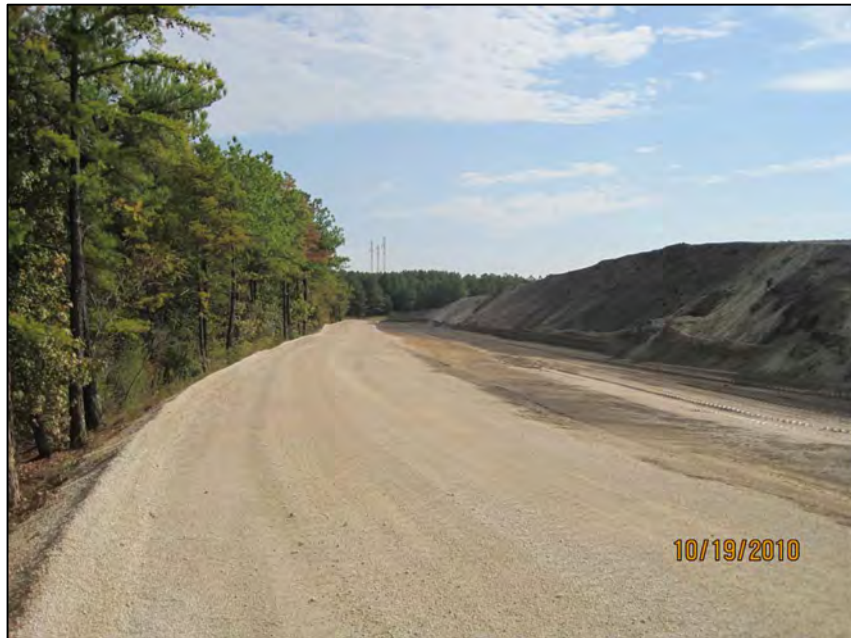
EAP-2
LOOKING NORTHEAST FROM
CREST OF NORTHERN EMBANKMENT

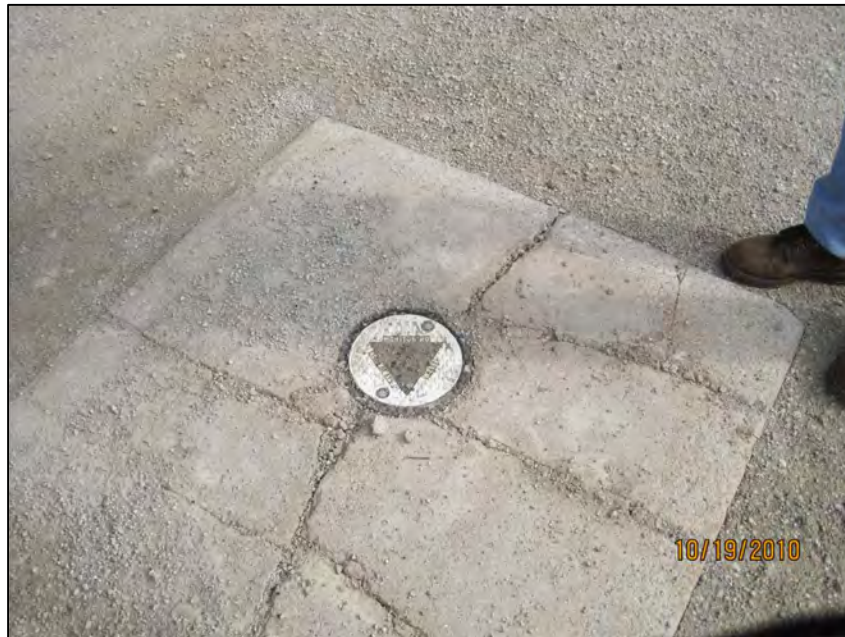
EAP-3
PIEZOMETER ON CREST OF NORTHERN EMBANKMENT

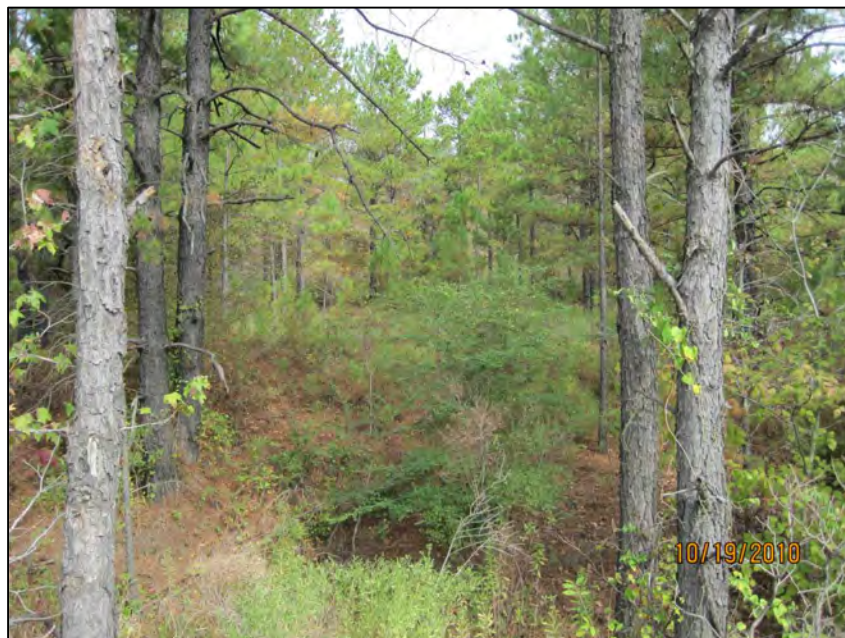
EAP-4
LOOKING NORTH FROM NORTHERN
EMBANKMENT AT HIGHER GROUND

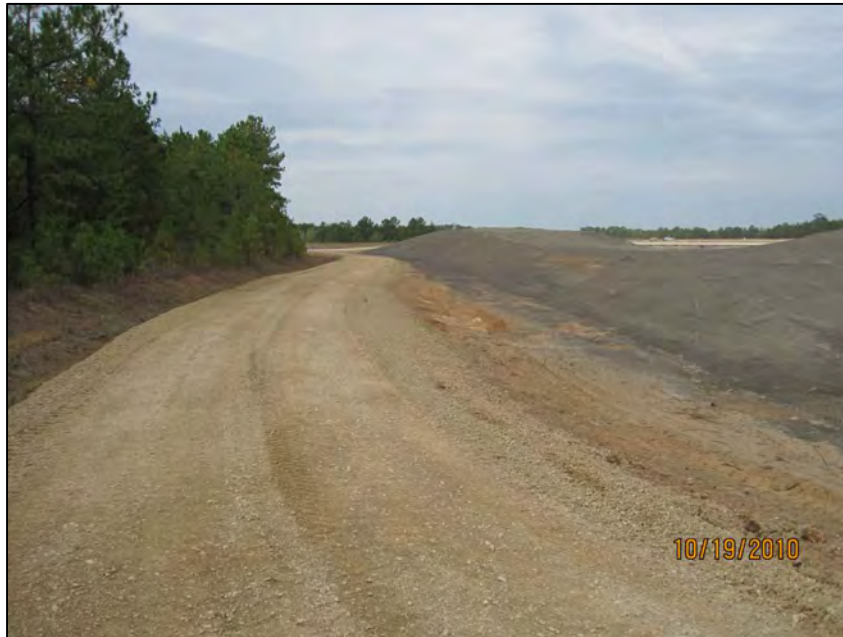
EAP-11
LOOKING WEST FROM SOUTHEAST CORNER CREST

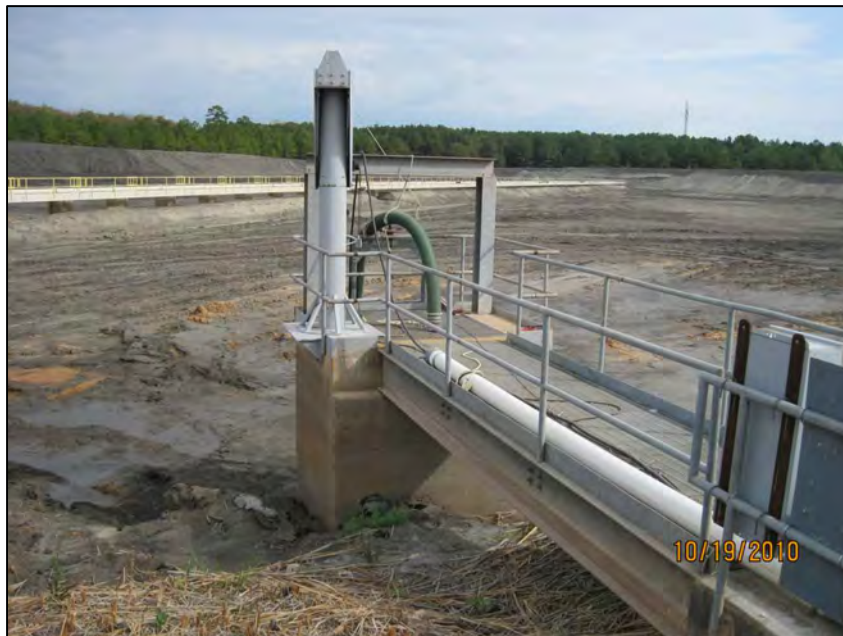
EAP-12
LOOKING NORTHEAST FROM SOUTHWEST
CORNER ACROSS DISCHARGE STRUCTURE

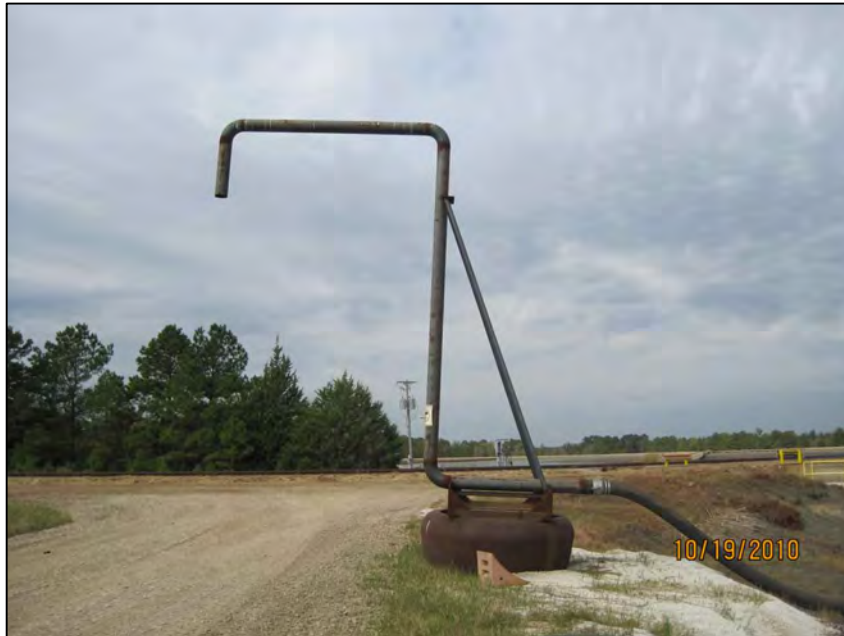
EAP-13
SOUTHWEST CREST LOOKING NORTHWEST
PAST DUST CONTROL LOAD OUT PIPE

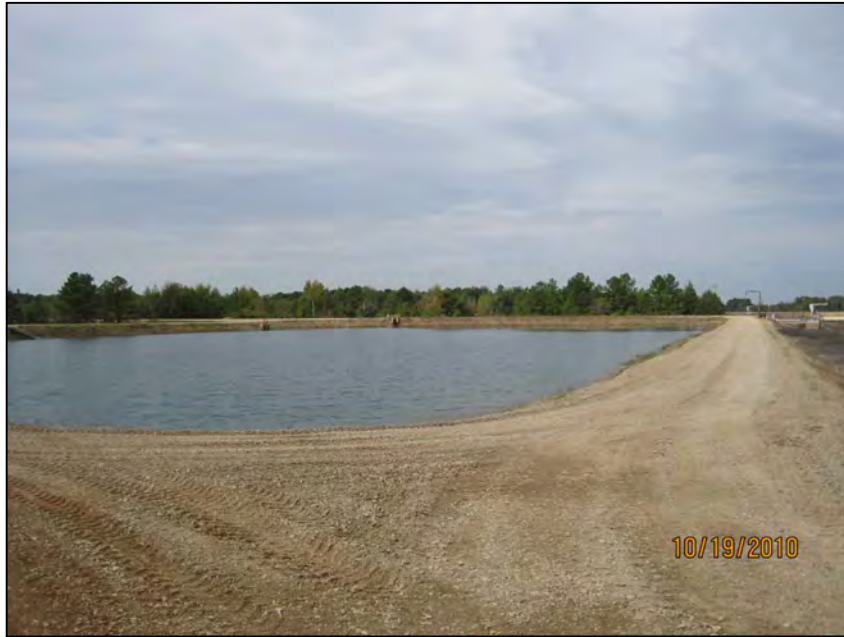
SAP-1
LOOKING WEST ACROSS POND FROM NORTHEAST CORNER

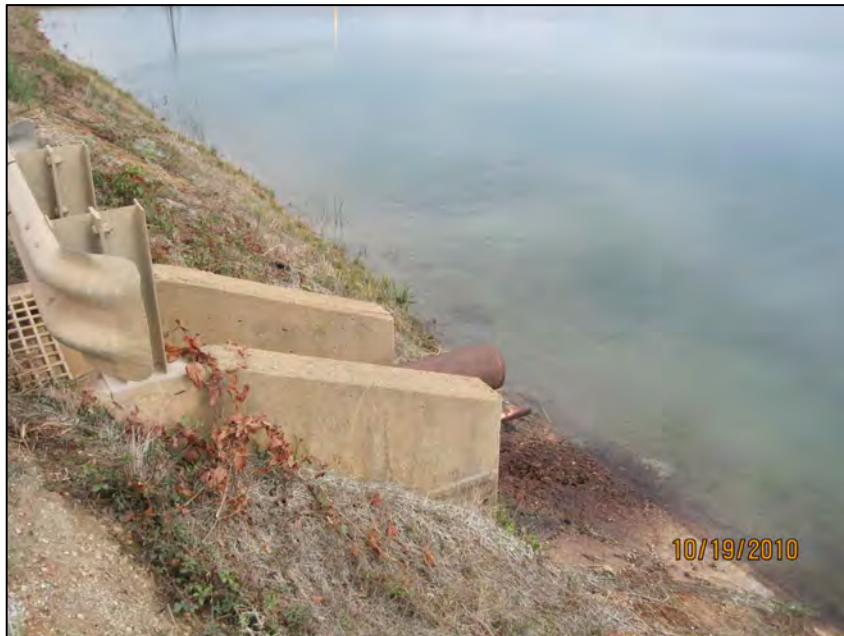
SAP-2
INFLUENT OF BOILER BLOWDOWN
DISCHARGE PIPE AT SOUTHWEST CORNER

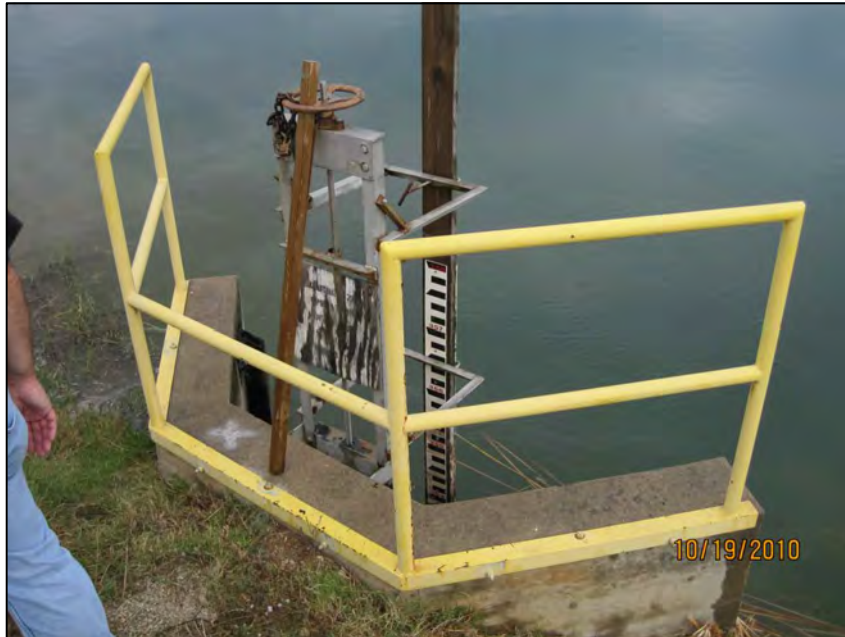
SAP-3

NPDES DISCHARGE OUTFALL 006 AT SOUTHWEST CORNER

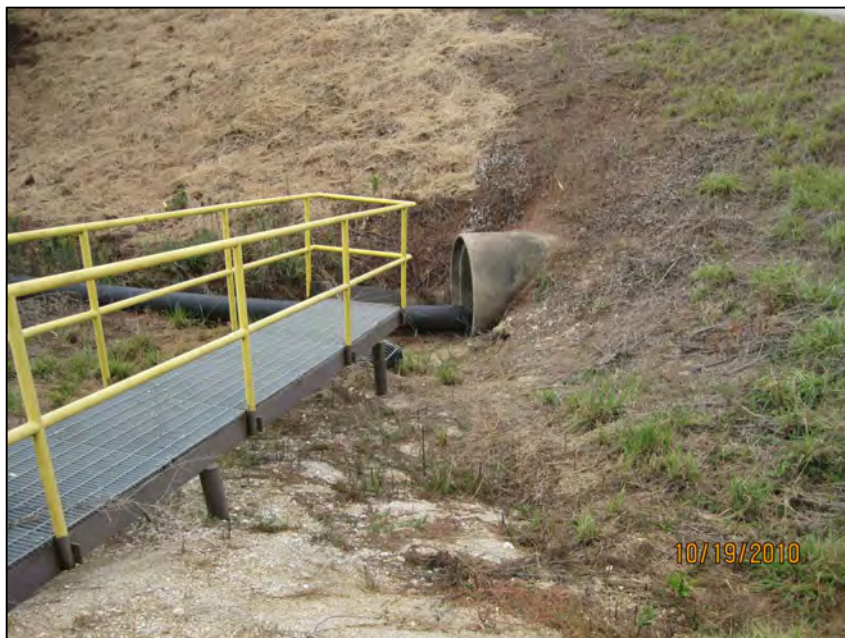
SAP-4

TRANSFER PIPE CARRYING REUSE
FLOW TO ADJACENT LIGNITE MINE

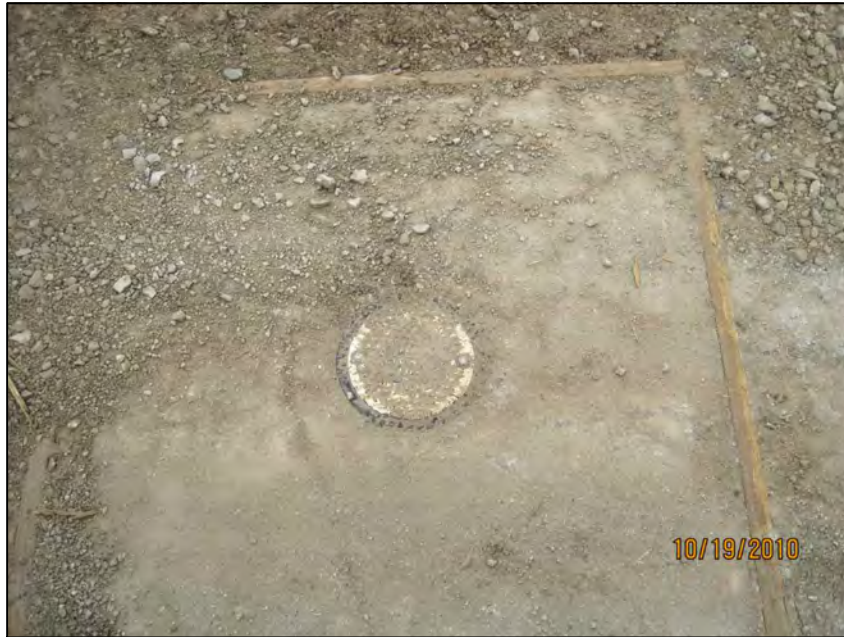
SAP-5
PIEZOMETER AT SOUTHWEST CORNER

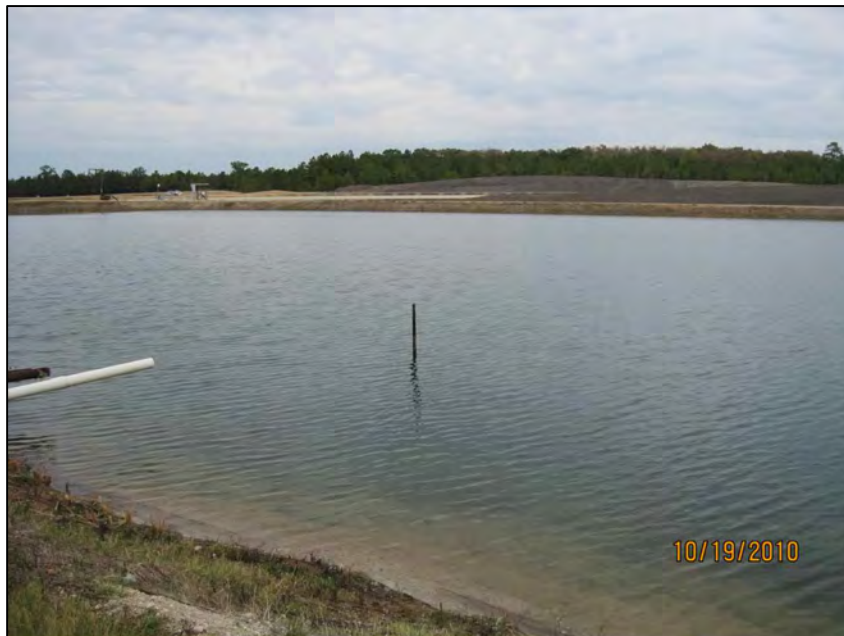
SAP-6
FROM SOUTHEAST CORNER LOOKING NORTHWEST AT
MARKER INDICATING LOCATION OF PLANT REUSE PIPE

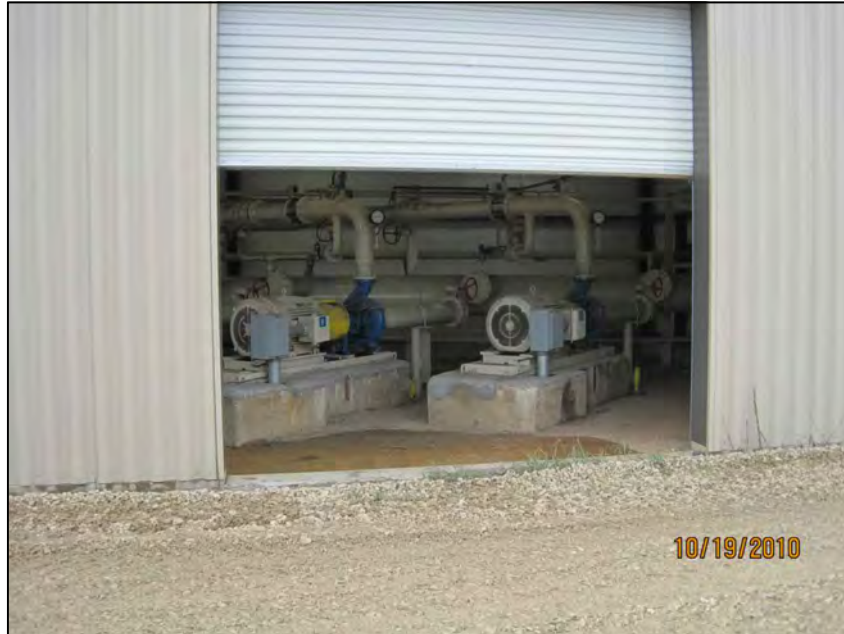
SAP-7
REUSE PUMP HOUSE ON SOUTH SHORE OF POND

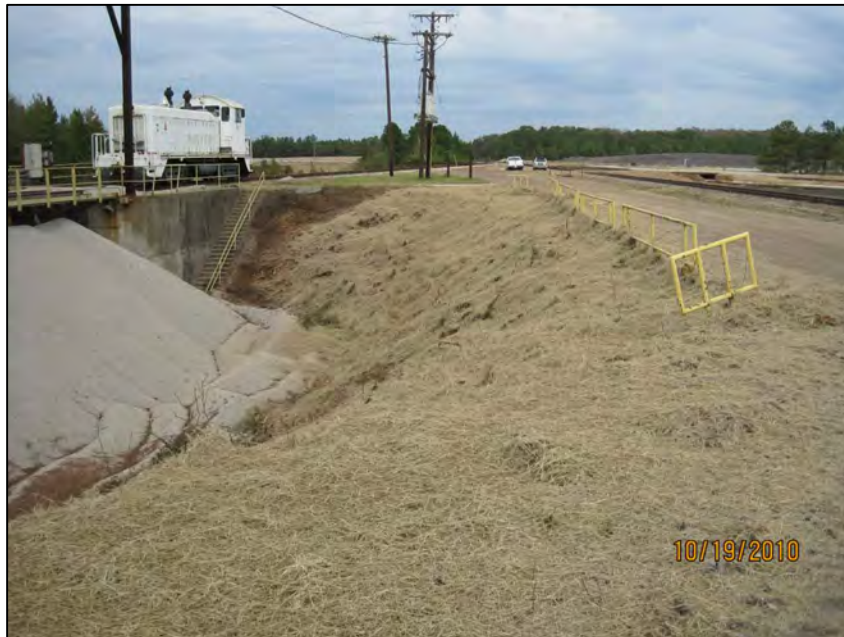
SP-3
WEST OF SURGE POND LOOKING NORTHWEST
AT LIMESTONE UNLOADING AREA

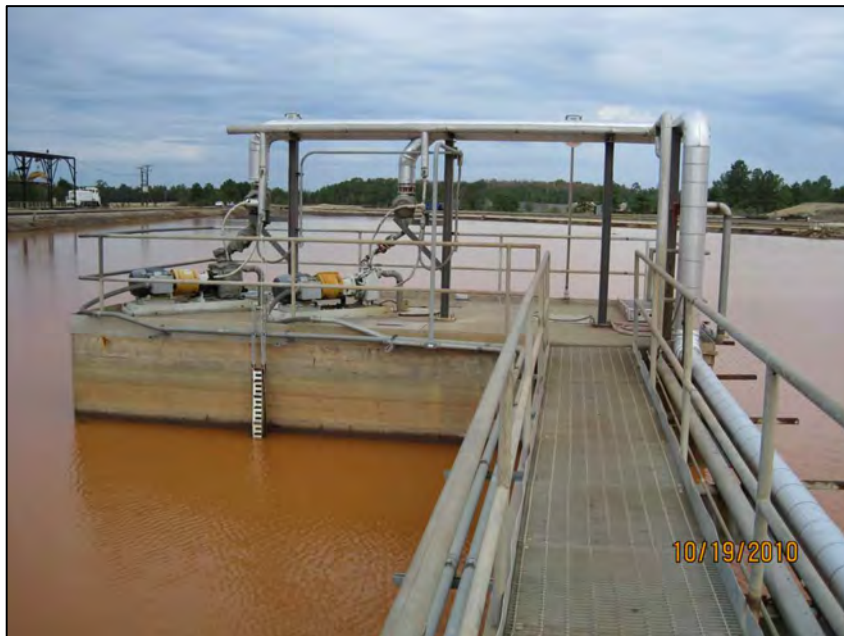
SP-6
LOOKING NORTH SOUTH EDGE OF POND
AT FACILITY REUSE PUMP STATION

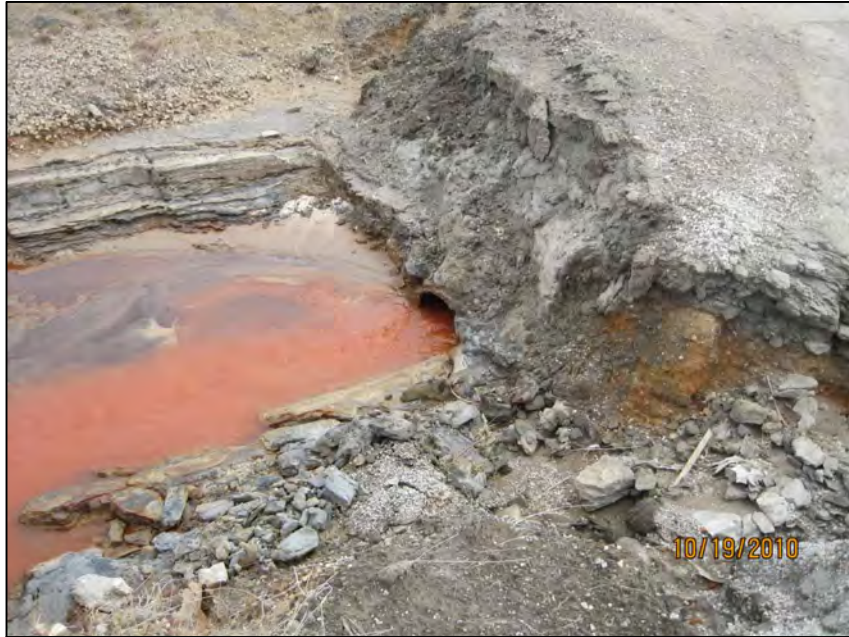
SP-7

SOUTHEAST CORNER OF POND LOOKING AT FLOWING FLUE
GAS DESULFURIZATION PROCESS INFLUENT PIPE (18-INCH)

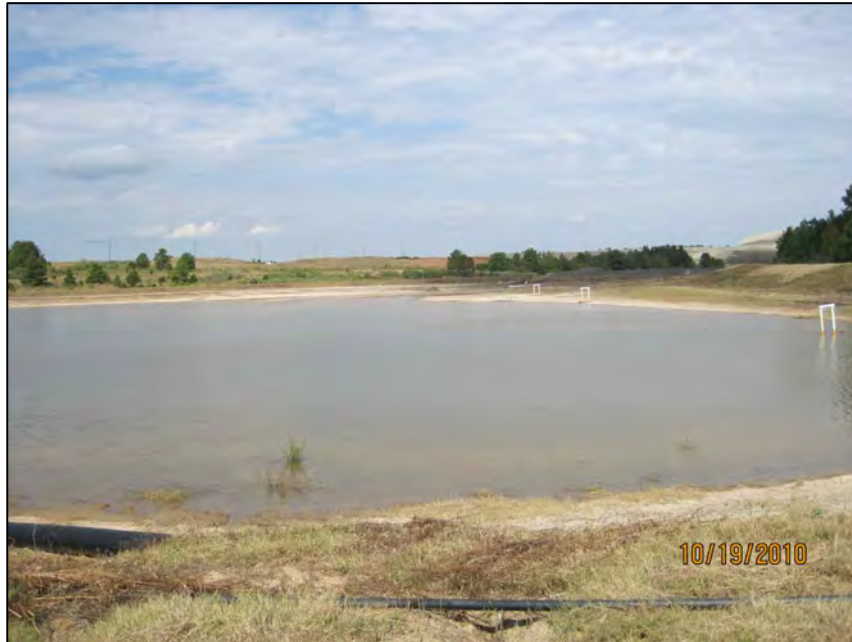
LRP-1
LOOKING NORTH ACROSS POND FROM
SOUTHEASTERN EMBANKMENT CREST

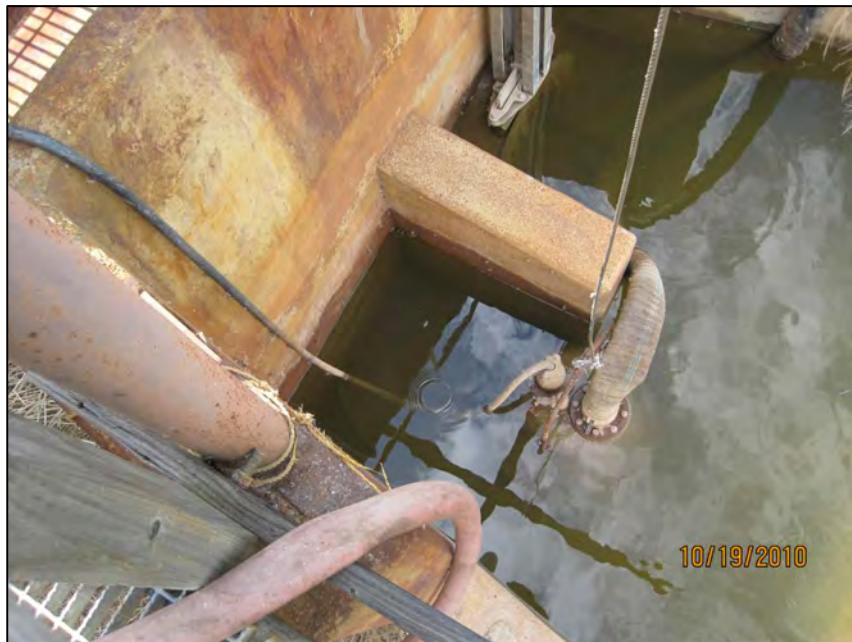
LRP-2
POND DISCHARGE STRUCTURE-NPDES OUTFALL 004

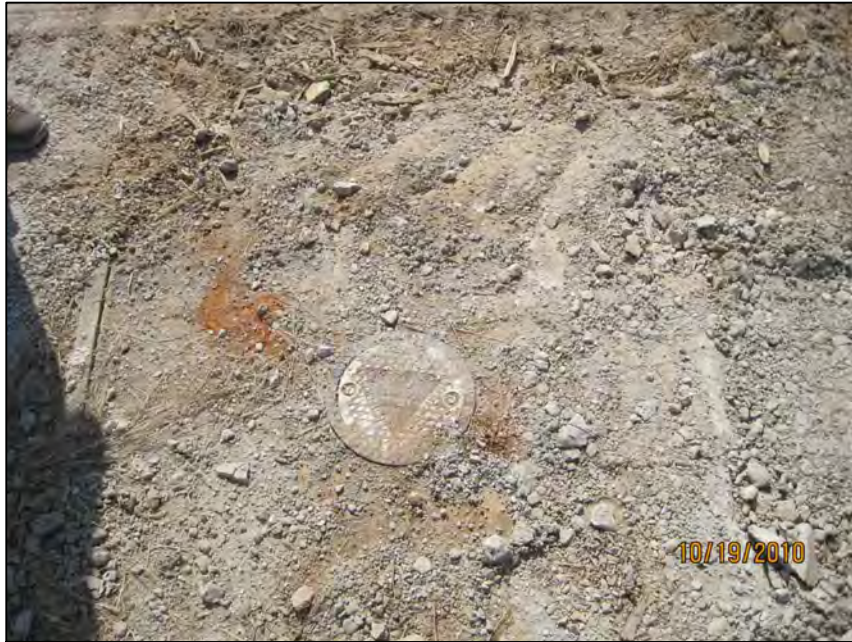
LRP-5
PIEZOMETER ON EMBANKMENT CREST

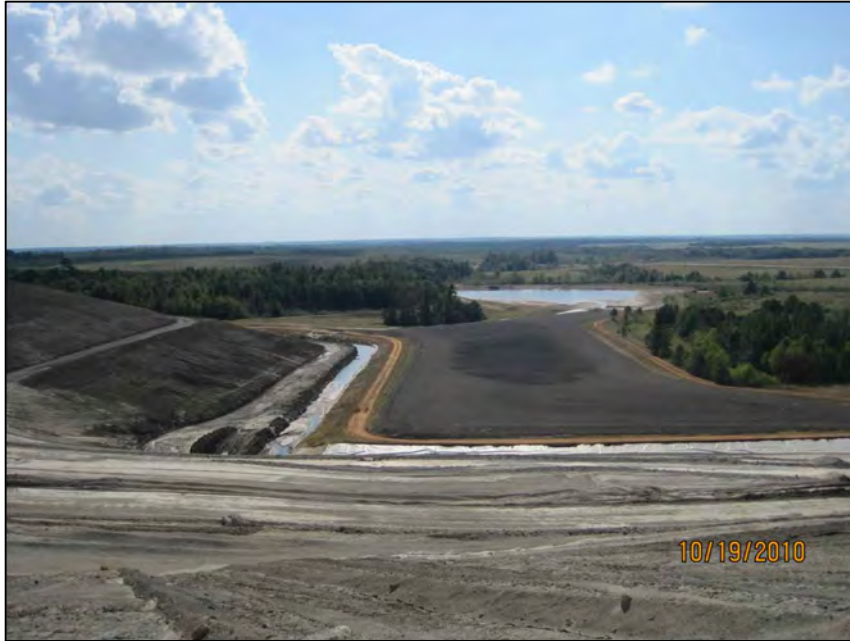
LRP-9
ATOP LANDFILL LOOKING SOUTHWEST AT LANDFILL
PERIMETER CHANNEL AND LANDFILL RUNOFF POND
